ATP test results for one Southern California hospital using the AccuPoint HC system over a three-month period in 2009 and 2010.

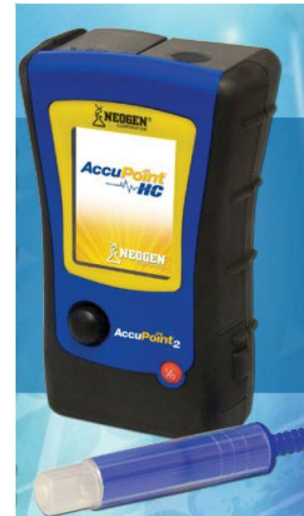
A Southern California hospital adopted the AccuPoint HC system in late 2009 for verifying and tracking their cleaning effectiveness in patient rooms. Five test sites were identified for their high-touch and high-risk value. They included the patient bed rails, overbed table, telephone, door knob to the patient rest room and the toilet seat in the patient restroom. The results were compiled in the AccuPoint HC instrument and downloaded to the Data Manager HC software program for further analysis. The charts below illustrate the results by test site over the three-month period and are compared to an established fail threshold (magenta line) and a trend line (in green).

Test results clearly show a trend toward both more consistent and lower scores over the three month period. This would indicate an improvement in both the effectiveness and consistency of cleaning efforts. When asked for an explanation on why the test results had improved, the Environmental Services Director stated, “the key is training and constant communication with all hospital staff”.
